AURIX™ TC36x errata sheet

Marking/Step: (E)ES-AA, AA

10527AERRA

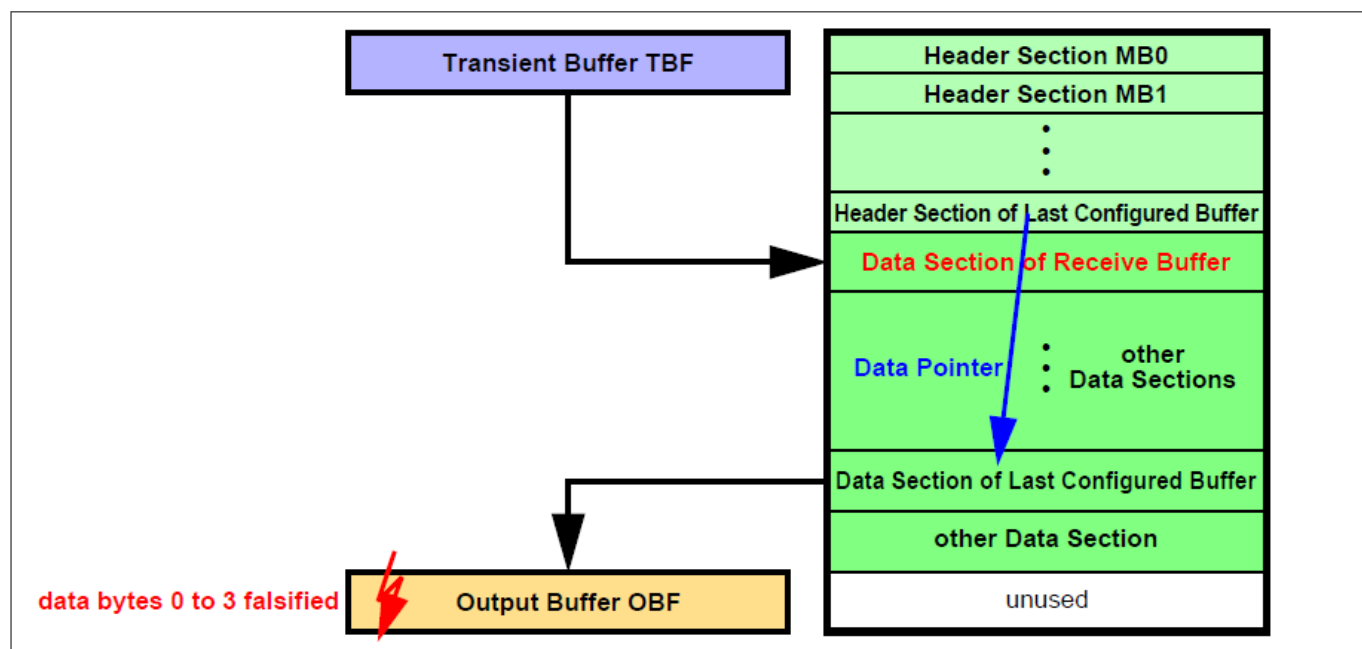
Figure 1 Message buffer transfer from Message RAM to OBF

When the message buffer has its payload configured to maximum length (PLC = 127), the OBF word on address 00h (payload data bytes 0 to 3) is overwritten with unexpected data at the end of the transfer.

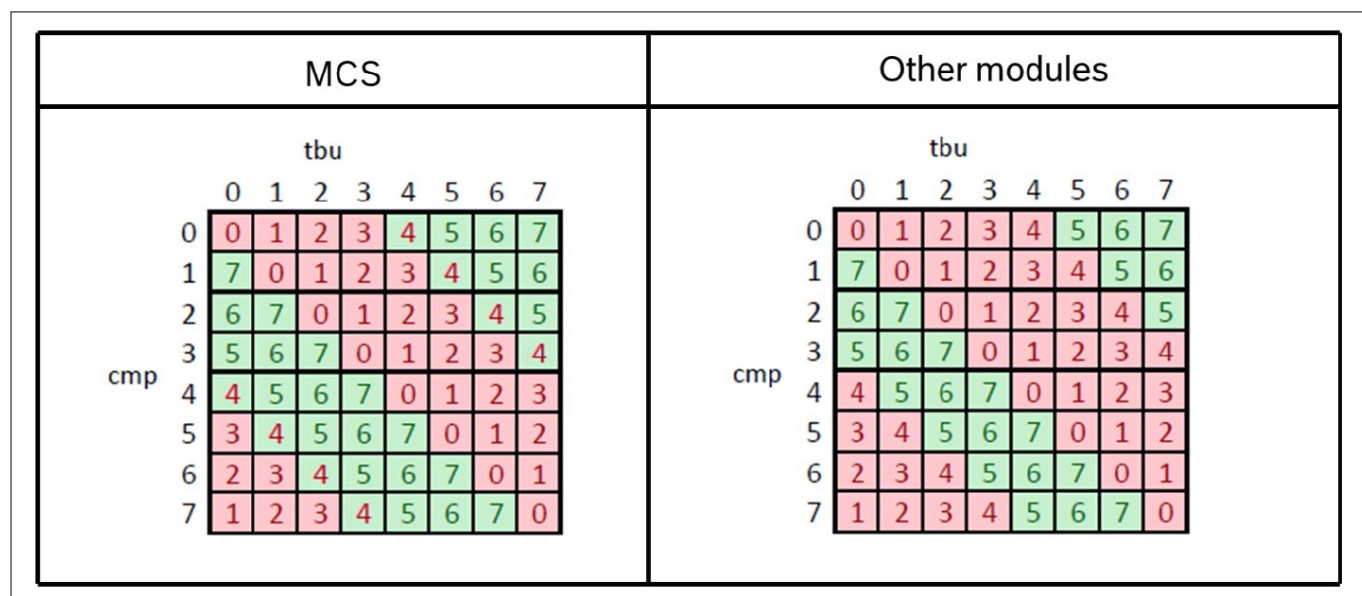
Figure 8 TBU value evaluation MCS against other modules. Red (past) and green (future).

With the revised specification of GTM 4.1 it was revealed that the implementation for the WUCE instruction is not correct for the boundaries. The implementation of the WUCE instruction has an inverted behavior for both boundaries between future and past.

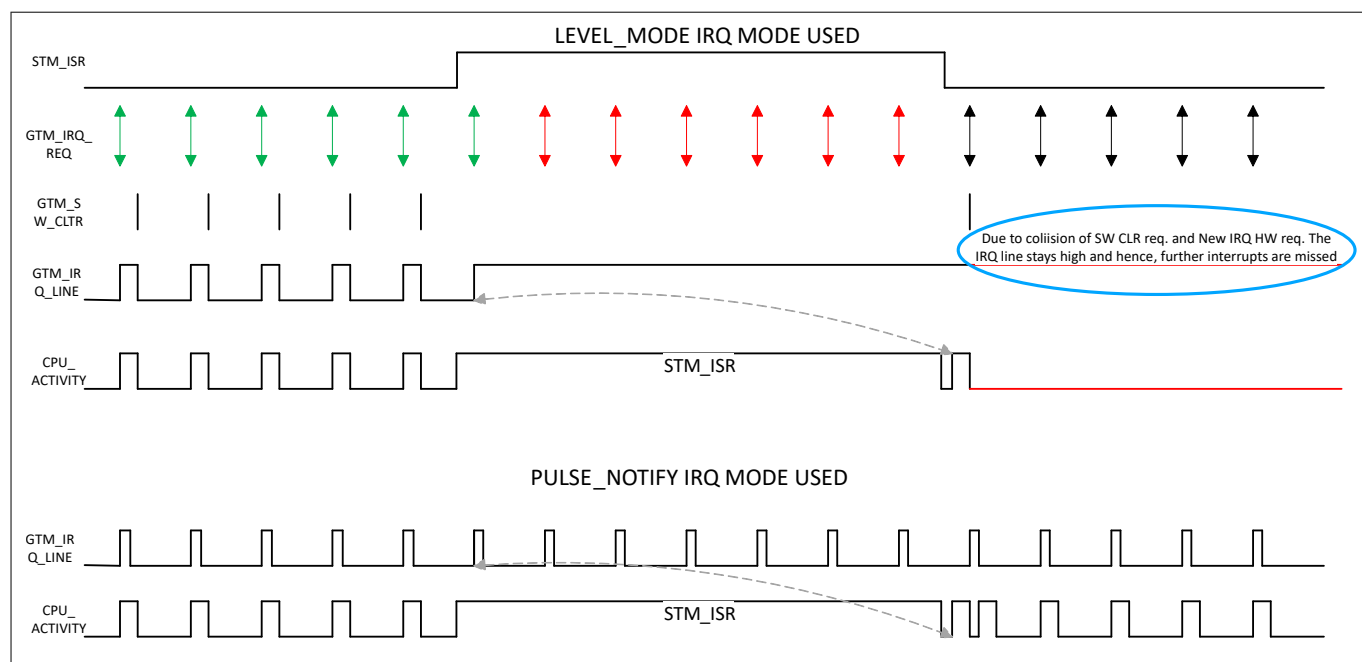
The event represented by the flags will be missed and not set in the registers. This affects the DPLL_STA_FLAG register as well as the MCS register DSTAX with the bit-fields: STA_FLAG_T, STA_FLAG_S, INC_CNT1_FLAG, INC_CNT2_FLAG.

Hence, in Level Mode, in some scenarios where another interrupt request is generated by GTM while the ISR handle also requests a SW clear, then, as the interrupt event is dominant over the clear event (for simultaneous interrupt and clear events), GTM_IRQ_XXX is not cleared and remains high. As a consequence, the IR observes no transition on GTM_IRQ_XX. Thus, any forthcoming interrupt events in this scenario are lost as there is no chance to release the CPU IRQ when a collision happens as shown in Figure below.

If Pulse-Notify mode is selected, every internal trigger will be forwarded to the IR, irrespective of the time of occurrence and the clear event, as the pulse-notify leads to set and reset of GTM_IRQ_XXX as compared to only setting of the GTM_IRQ_XXX line in Level mode.

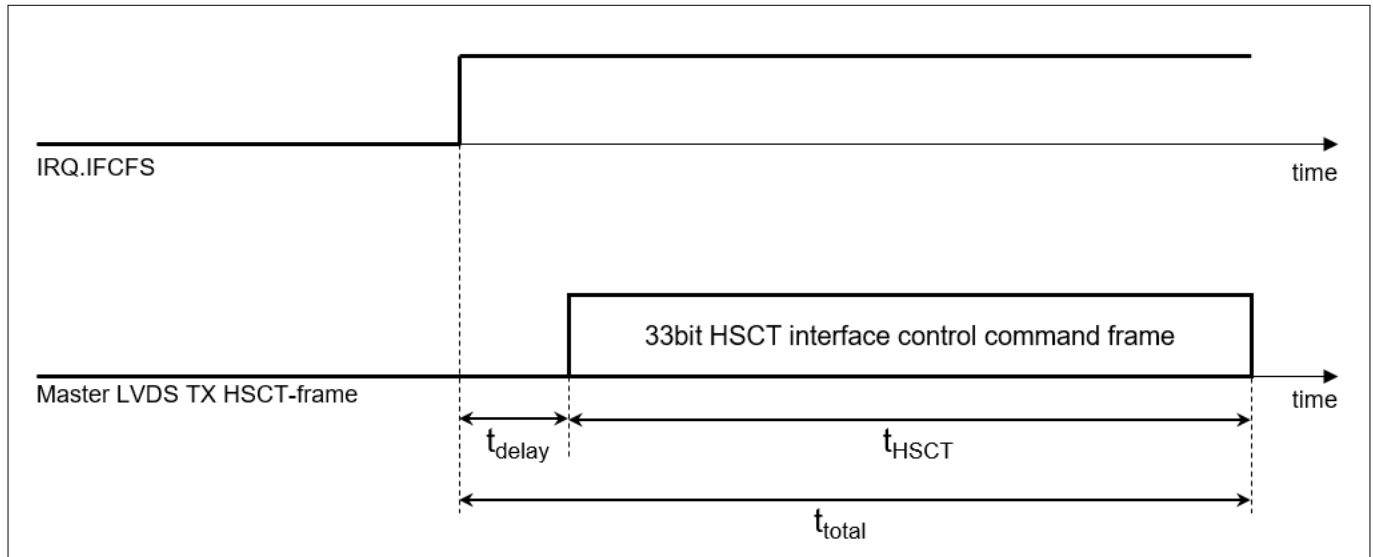
Figure 12 Timing of LVDS TX interface command sending in relation to IRQ.IFCFS

the user might falsely assume that also the actual sending on the LVDS TX port has already occurred once the IRQ.IFCFS flag is set, which is not true.

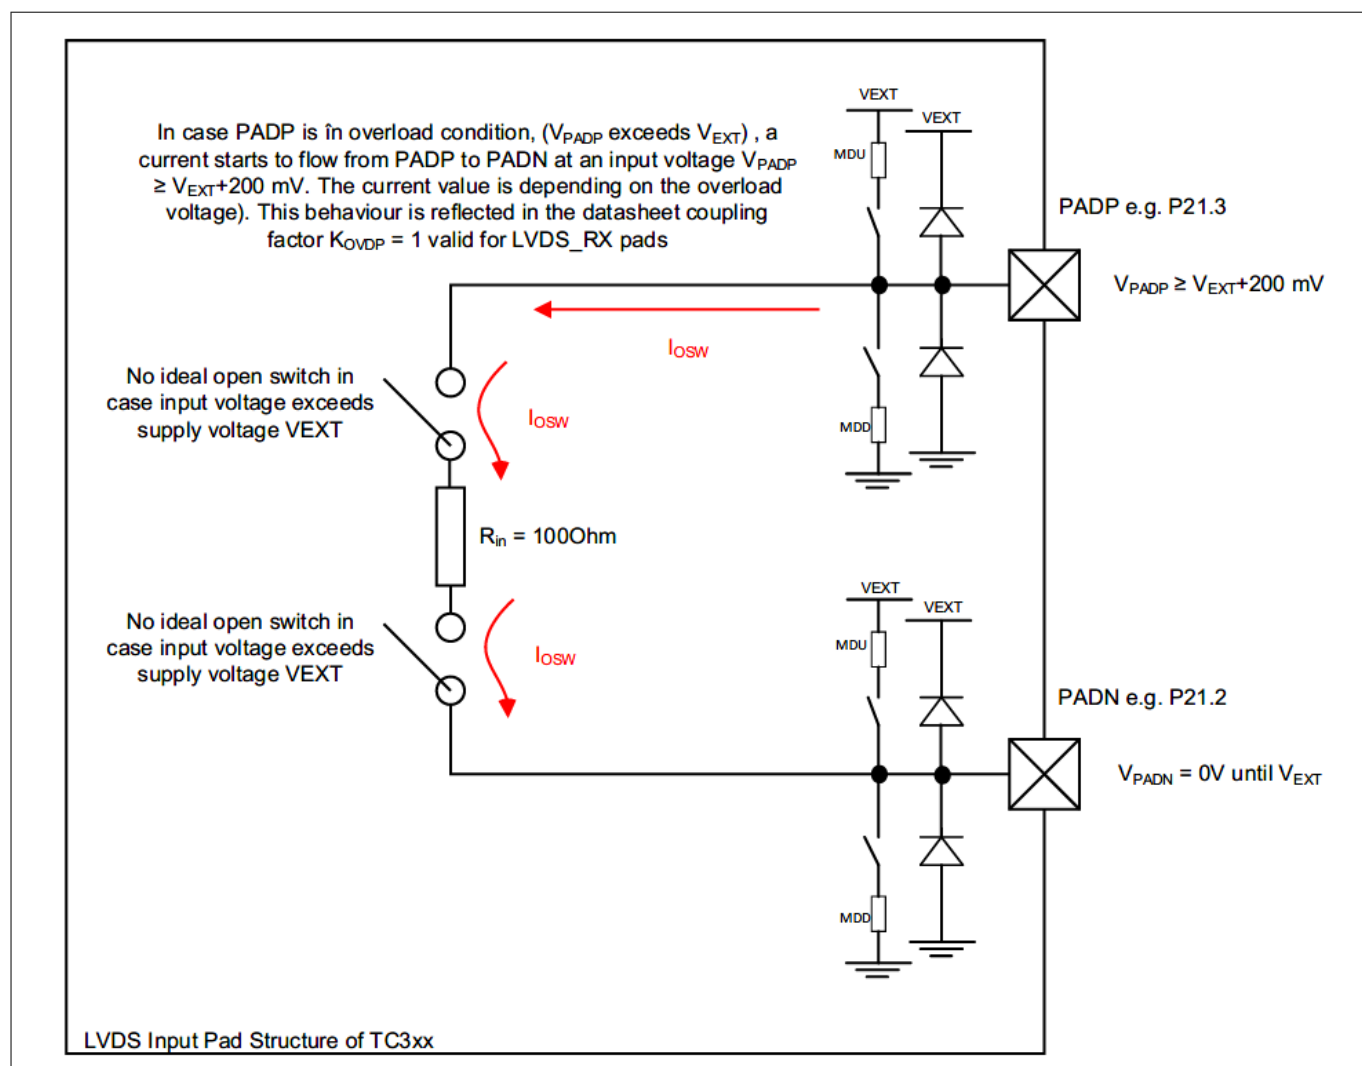
Figure 16 Positive overload on P-pad of a LVDS RX pin pair (both used as inputs)

The overload current I_{OSW} through the non-ideal open switch significantly increases when $V_{PADP} \geq V_{EXT} + 200 \text{ mV}$.

Note: In general, the effect will also occur if the N-pad is used as output, or for a negative overload condition on either the P-pad or the N-pad.
