AURIX™ TC36x errata sheet

Marking/Step: (E)ES-AA, AA

10527AERRA

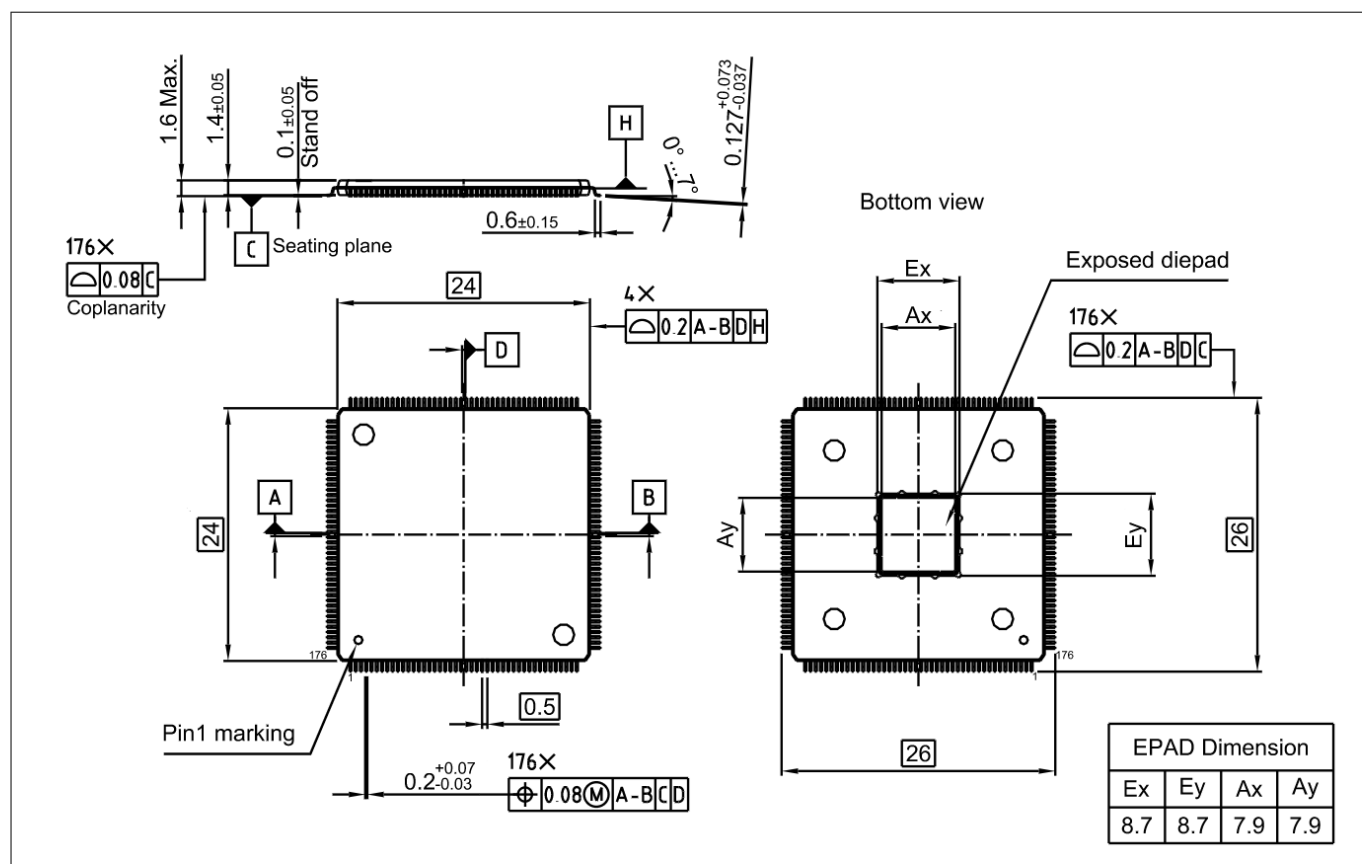
Figure 13 Package Outlines LQFP-176 for TC36x

Note: For the exposed diepad of the LQFP-176 package of the TC36x, structural corner protrusions have to be considered for purposes of system design and integration with a maximum boundary of 9.4 mm.

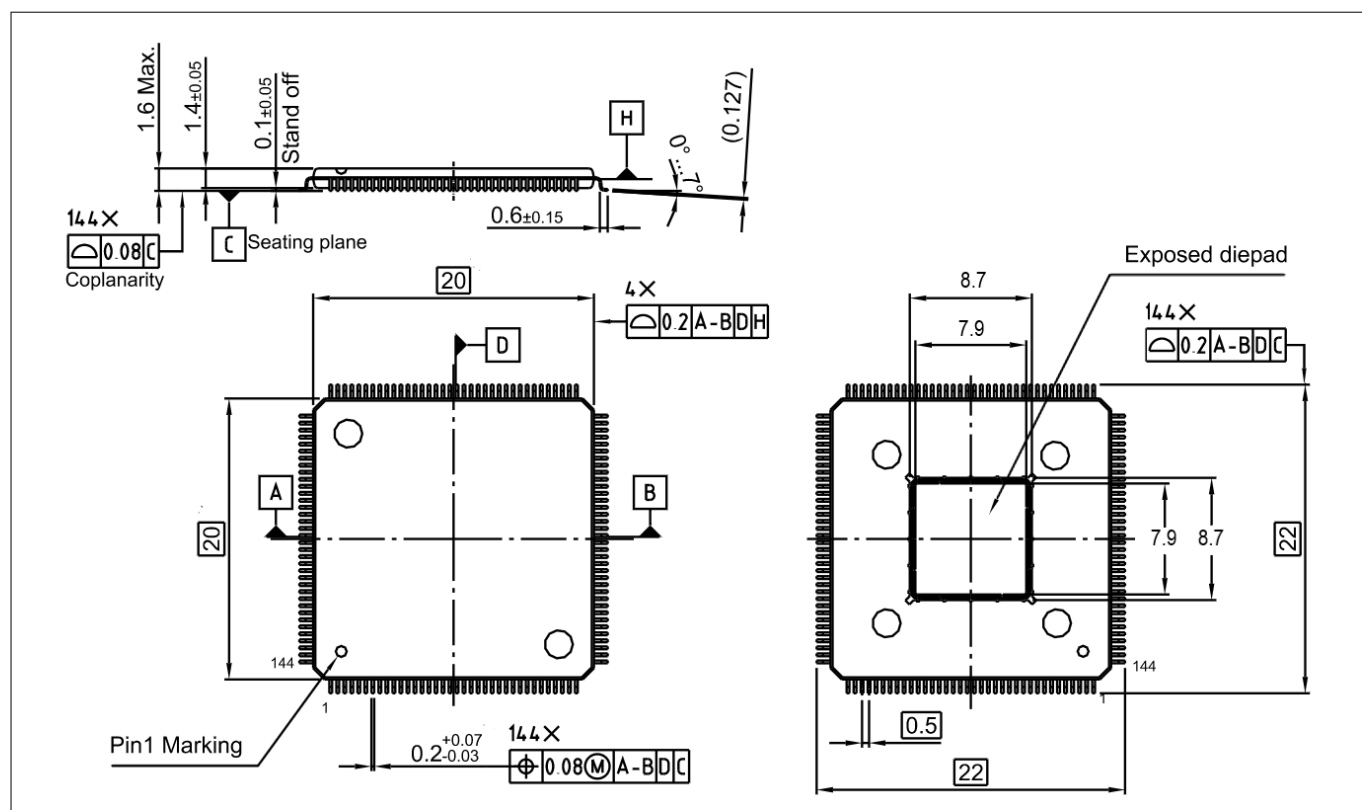
Figure 14 Package Outlines LQFP-144 for TC36x

Note: For the exposed diepad of the LQFP-144 package of the TC36x, structural corner protrusions have to be considered for purposes of system design and integration with a maximum boundary of 9.4 mm.

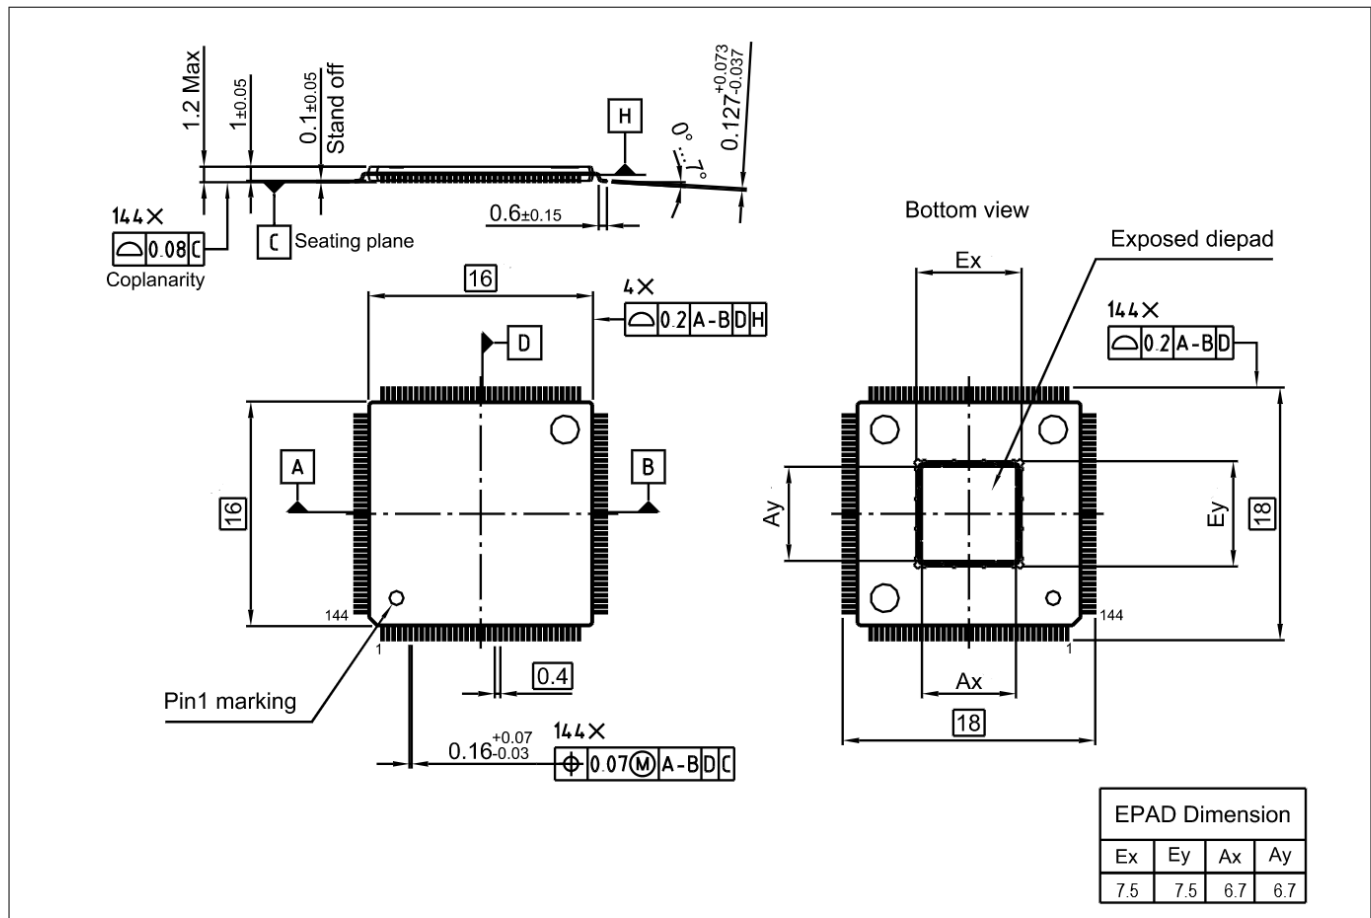
Figure 15 Package Outlines TQFP-144 for TC36x

Note: For the exposed diepad of the TQFP-144 package of the TC36x, structural corner protrusions have to be considered for purposes of system design and integration with a maximum boundary of 8.0 mm.
